**NUMERICAL INVESTIGATION ON THE
EFFECTIVENESS OF SEISMIC RETROFITTING OF A
HISTORICAL MASONRY MOSQUE**

Master of Science Thesis

Program in Mechanics, Department of Civil Engineering

Anadolu University

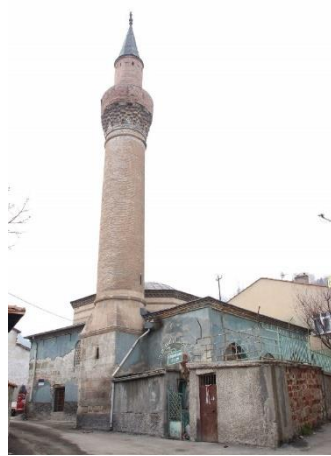
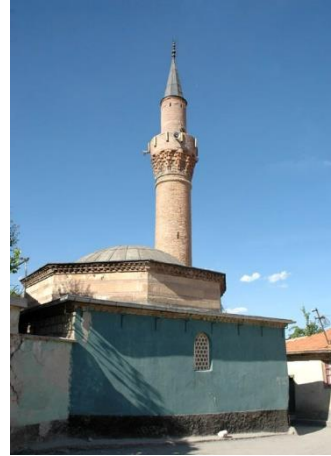
Figure 2.4. Kütahya Kurşunlu Mosque before intervention started in 2013

Although the mosque is standing for centuries, it is obvious that a such structure experienced human origin and natural origin damage during its life span and today the current condition of the structure differs from its original design due to adopted interventions. In Figure 2.4, the condition of the Kütahya Kurşunlu Mosque before restoration and retrofitting works started in 2013 is shown. It is possible to say that the last conservation works was done without considering principle of minimum intervention (admitted by ICOMOS) and used without any respect to the heritage building. The plastering and blue wall painting was applied on the masonry walls and additional brick walls and rooms were added. Consequently, the heritage structure was far behind its cultural and historical legacy and it was almost impossible to identify as an ancient building due to its appearance.

(a) North-East façade (Http-8)

(b) South façade (Http-9)

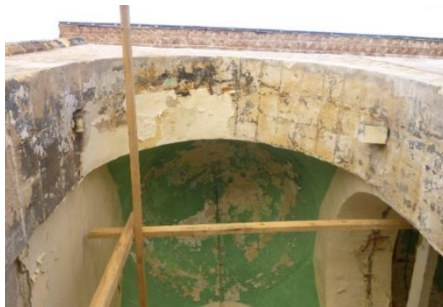
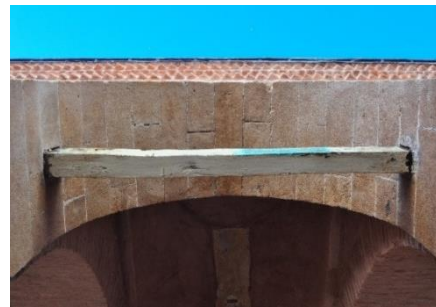
Figure 2.6. Connected wooden tie beams on the arch elements of portico

- i. At the time of in-situ inspection, restoration works were completed for the minaret. Therefore, no damage is reported on the minaret.
- ii. Some of the wooden tie beams, which were used as tension tie to overcome tensile stresses developed on the arch elements, were removed. On the other hand, material decay is observed on the existing wooden tie beams (Figure 2.6).

(a) Removed wooden tie beam

(b) Material decay on the wooden tie beam

Scientific committee of the restoration and retrofitting of Kütahya Kurşunlu Mosque suggested to replace those tie beam elements with steel tie rods. It is worth to mention that these tie beam elements contribute to the response of the arch system. Especially, it is much important when the arch element is composed of masonry material because masonry is known with its low tensile capacity. A representative example of an arch system was conducted by using SAP2000. When an arch is affected under gravity loads only, the variation in moment, shear and axial load in the arch was displayed for two extreme support conditions in Figure 2.7. Change in arch response was investigated when the tie beams are provided to the system as shown in Figure 2.7.

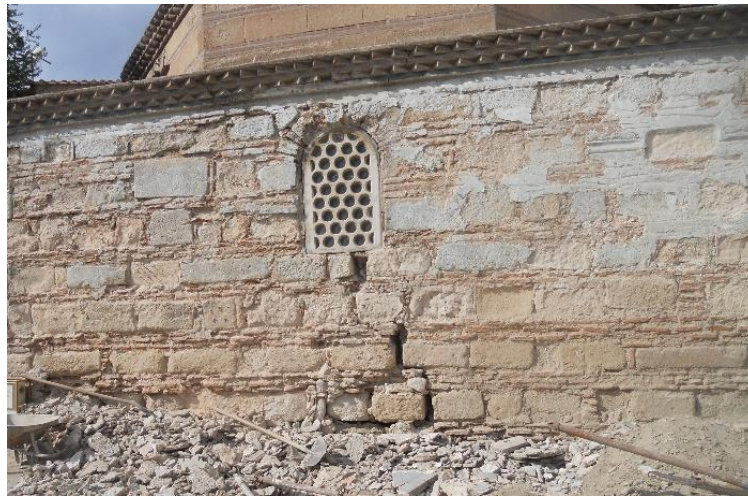
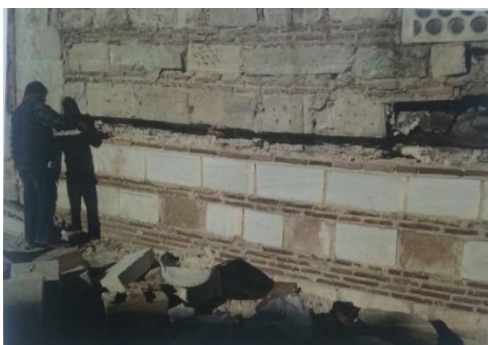
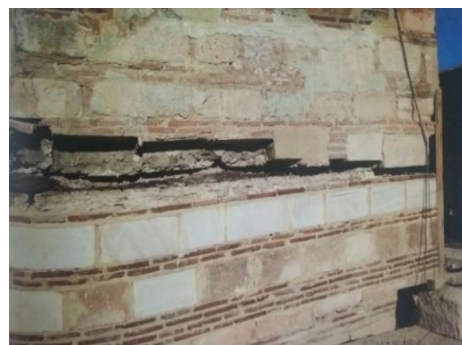
Figure 2.8. Visual observations on the South Wall

- iii. Severe damage was observed on the South Wall. The crack initiated vertically from the top level of the wall façade and the width of the crack below the window opening was reached up to centimeters as shown in Figure 2.8(a). Additionally, loss of wooden beams located along the South Wall was reported. Wooden beams were in charge of compensating low tensile strength of the masonry elements in the load bearing wall cross sections (Figure 2.8(b)).

(a) Vertical cracks

(b) Material decay on the wooden beam located in the South Wall

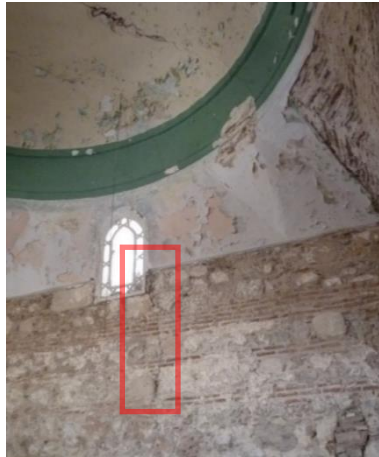
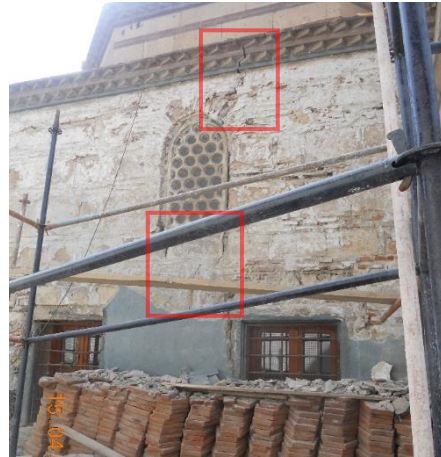
Figure 2.9. Vertical cracks

- iv. Vertical cracks, which are indicators of out-of-plane bending, were observed on the load bearing walls of the prayer hall. These cracks were initiated around the window openings. A decrease was observed in the crack size of the wall along the height (Figure 2.9).

(a) West Wall

(b) East façade

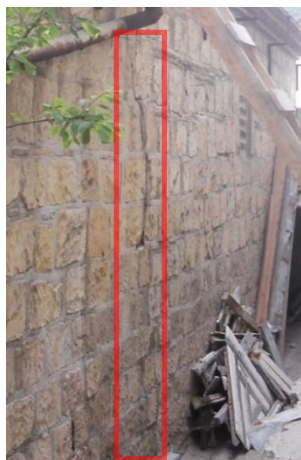
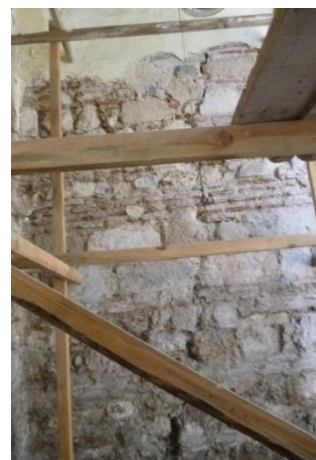
Figure 2.10. Damage observed on the West Wall

- v. On the West façade of the mosque, a distinct vertical crack was noted. The location of the vertical crack corresponds to the intersection of the two perpendicular walls, North and West Prayer Hall Walls, and West Portico Wall (outer leave, Figure 2.10(a)). The damage can be related with the lack of connection between structural elements. Another vertical crack was observed in the middle of the West Portico Wall (inner layer). The crack propagates along the height of the wall as given in Figure 2.10(b).

(a) Intersection of the Prayer Hall and Portico

(b) Crack on the West Portico Wall, inner layer

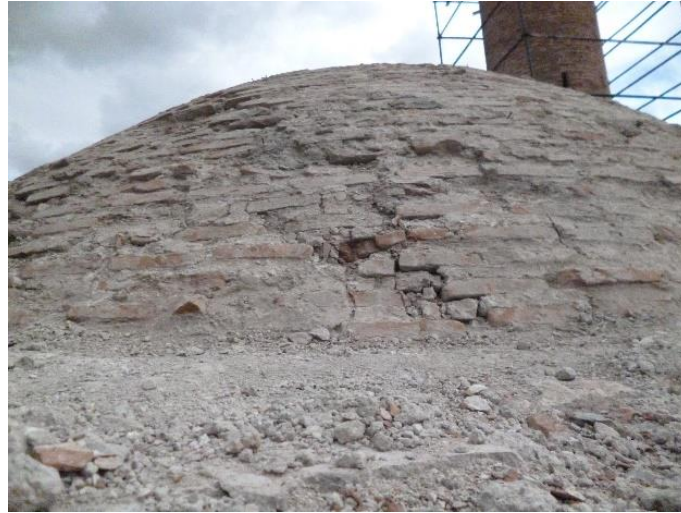
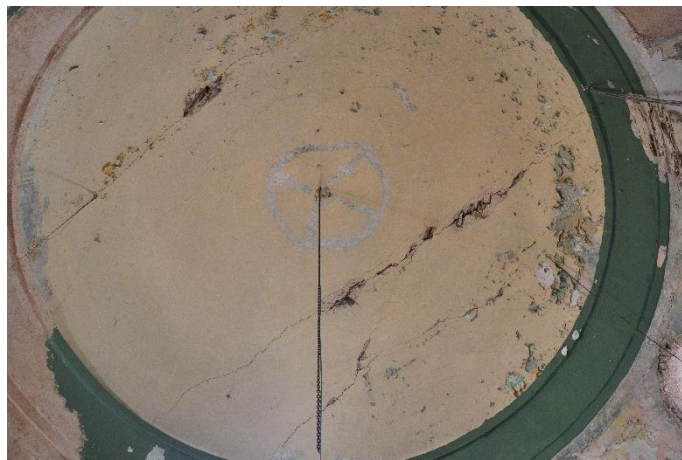
- vi. Extensive damage is reported not only at the intrados but also at the extrados when lead surface cover of the dome was removed. It is possible to say that the stability of the dome is debatable for the future events due to the existing crack propagation (Figure 2.11).

(a) Crack observed on the extrados

(b) Crack observed on the intrados

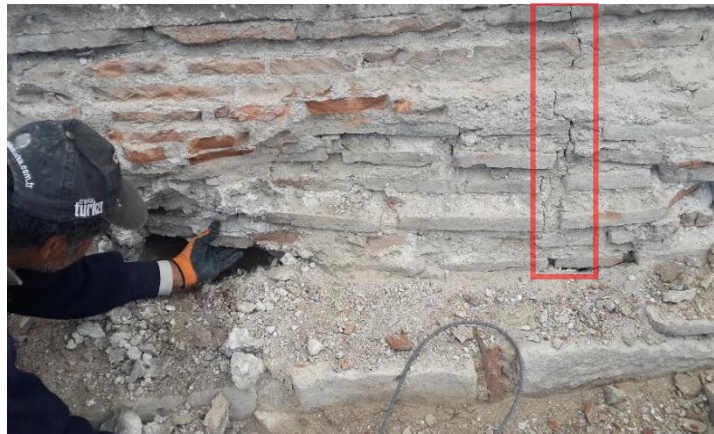
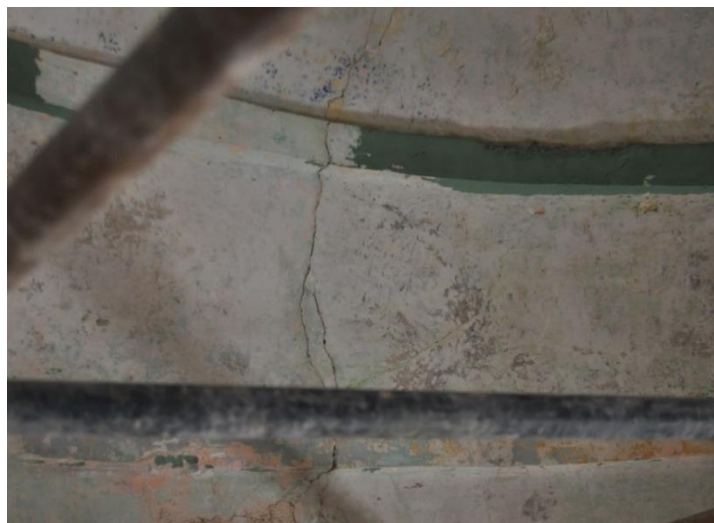
- vii. Additionally, vertical cracks were noticed on the octagonal drum, both interior and exterior surfaces (Figure 2.12). It is believed that the structural walls exhibited out-of-plane movement so that opening of the octagonal drum, support of the dome, can be concluded. In fact, lack of integral behavior of the mosque contributed to the cracks observed on the octagonal drum which followed the crack propagation on the dome.

(a) Exterior crack on the octagonal drum

(b) Interior crack on the octagonal drum

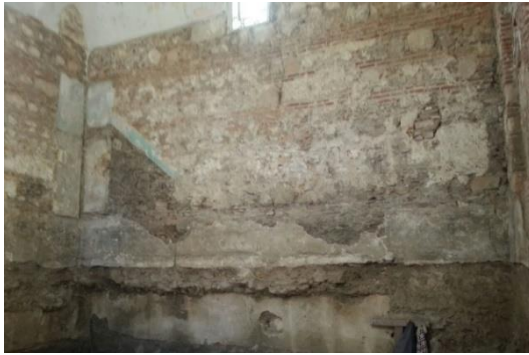
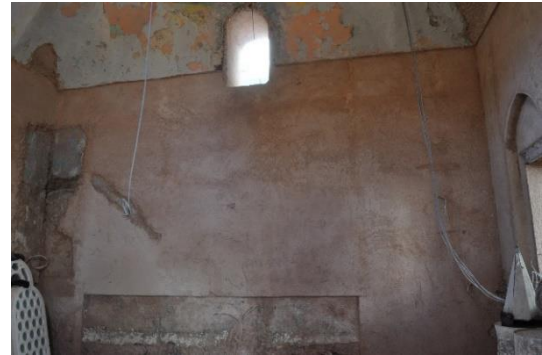
Figure 2.13. *Grout injection*

In this context, different repair works were carried out. High strength grout injection was applied to the load bearing walls so as to provide integration between masonry units through the crack openings (Figure 2.13). The latter, the stitching technique was implemented to the damage observed on the dome. Stainless steel elements were used to prevent the widening of existing cracks (Figure 2.14).

(a) Before

(b) After

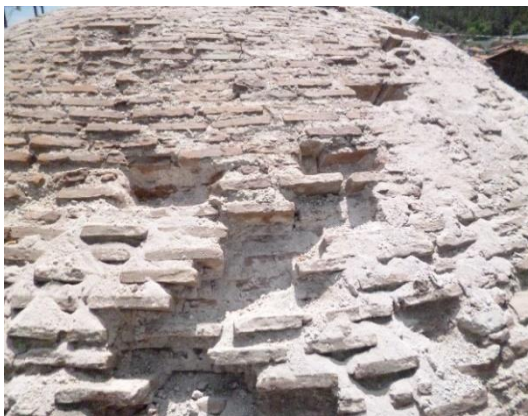
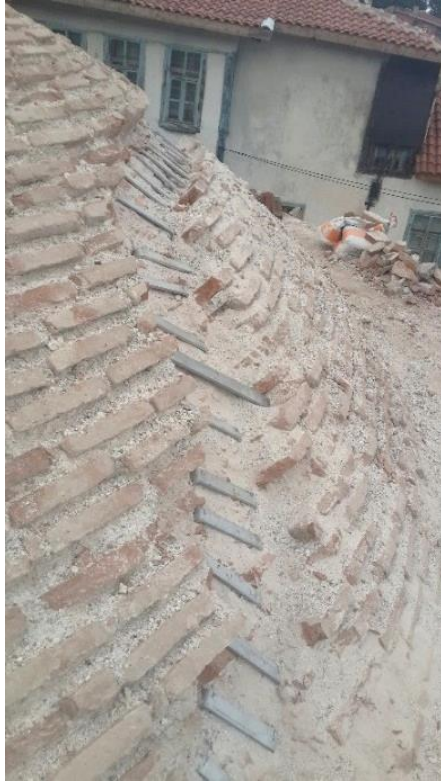
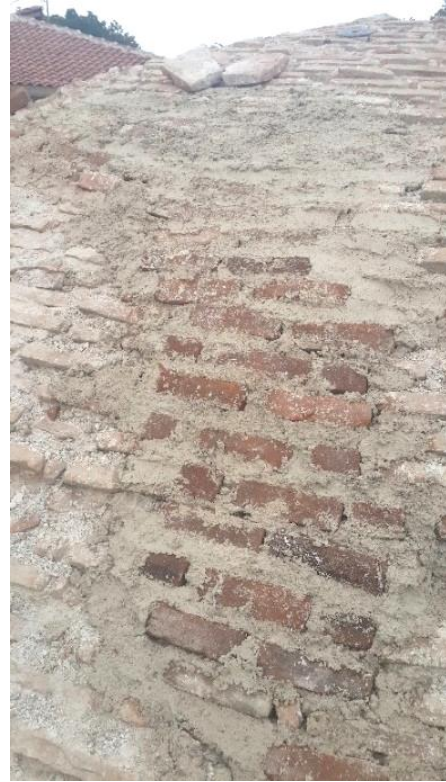
Figure 2.14. *Application of stitching technique on the extrados*

Firstly, the old material beside the crack line at the extrados was removed. Stainless steel elements were fixed in the perpendicular direction of the crack line, after high strength grout injection was applied to the crack openings. Finally, steel elements were covered by masonry material which were compatible with the old material (Figure 2.14). In case of high tensile stresses, the stress distribution is expected on the masonry units with low tensile capacity where the steel elements are fixed. Additional cracks are expected due to change in high tensile stress distribution. Therefore, additional improvements are necessary in order to overcome the crack opening and ensure structural safety.

(a) Removing the old material

(c) *Stainless steel elements fixed along the crack*

(e) *Covering the steel elements*

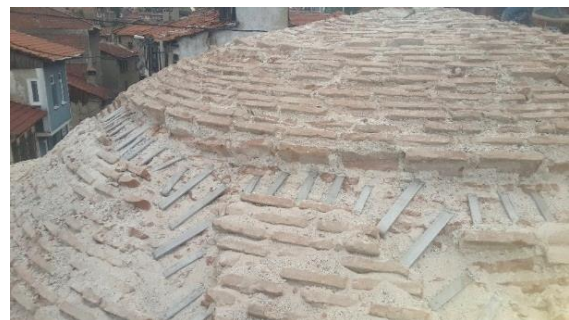
(b) Stainless steel elements along the crack

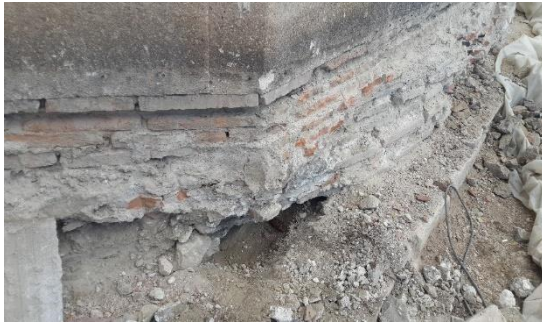
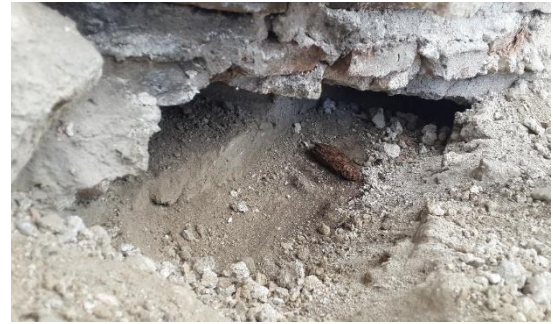
Figure 2.16. Loss of wooden beam elements at the bottom part of the drum

(a) Part of the octagonal drum

(b) Loss of wooden beam

The historical mosque was undergone restoration as mentioned previously, however seismic retrofitting is crucial to a such building with severe damage. Therefore, steel girder retrofitting was implemented to the ancient mosque by considering the principle of minimum interventions and reversibility. Within the scope of the present thesis, the effectiveness of the steel girder retrofitting was investigated by using numerical method. The configuration of the steel girder retrofitting is depicted in Figure 2.15. U-section stainless steel elements were used. Steel girder retrofitting was decided based on two issues; (i) damage observed in the dome, (ii) damage observed on the structural walls. In old construction techniques, wooden beam elements were used for masonry mosques at the bottom level of the dome in order to compensate tensile stresses. In this sense, old brick material was removed from the bottom level of the drum to check the condition of wooden beams. Hence, total loss of wooden beams was reported (Figure 2.16). The loss of those tension elements would probably have contributed to the damage observed. Therefore, single U160 stainless steel elements were placed not only at the base (empty)

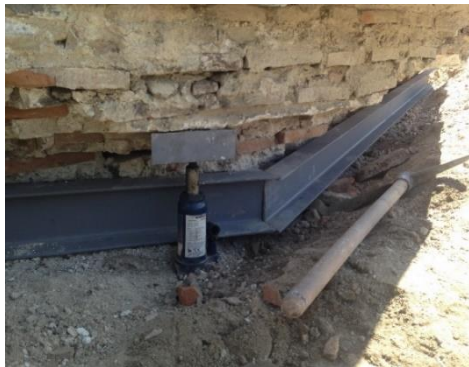
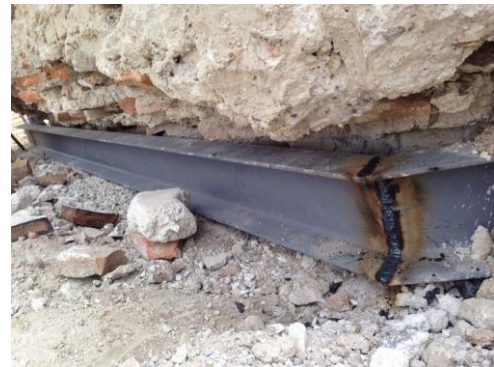
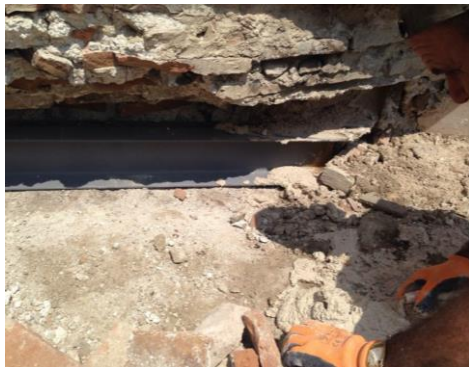
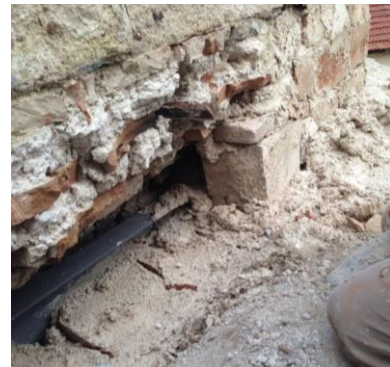
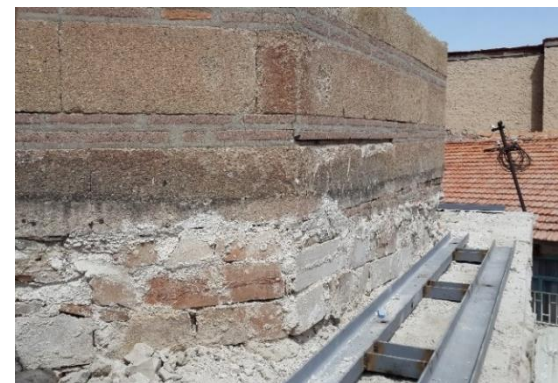
Figure 2.17. Steel girder application steps

section of the drum (Figure 2.17(a)) but also at the top of the drum walls (Figure 2.18). Each steel element was welded to each other (Figure 2.17(b)). Following that, space between steel elements and masonry material was filled with hydraulic lime-based mortar (Figure 2.17(c)). Finally, steel elements were covered by masonry units which are compatible with the old material (Figure 2.17(d)). It is expected that these elements provide additional support system to the dome and limit the expansion of existing cracks in case of any action.

(a) Steel girder at the bottom section of the drum

(b) Welded connection

(c) Hydraulic lime based mortar injection and covering

(d) Covering the girders with new masonry material

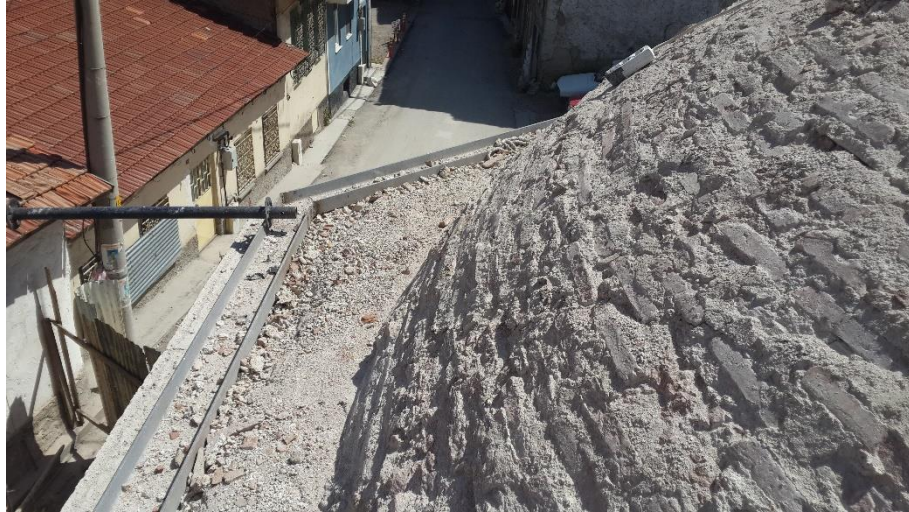
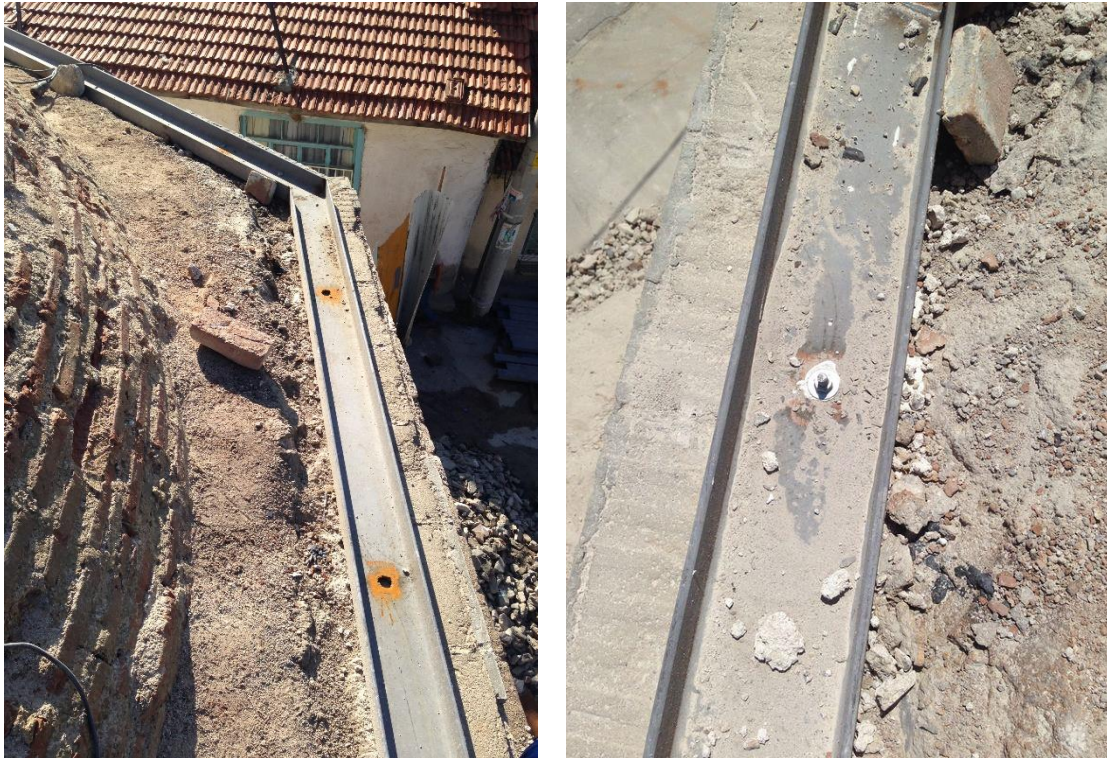
Figure 2.18. *Single bar U160 steel girder at the top section of the drum and anchorage connection*

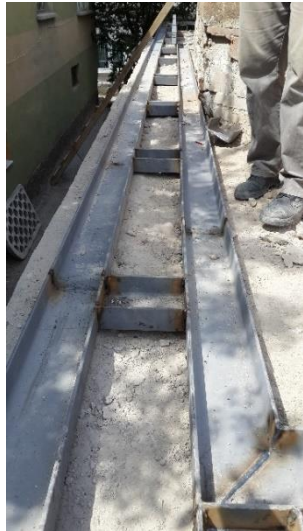
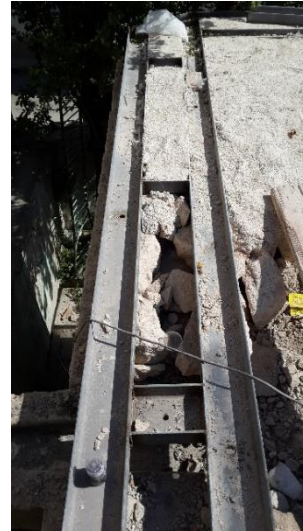
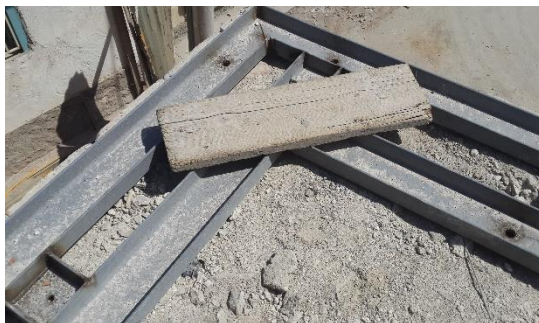
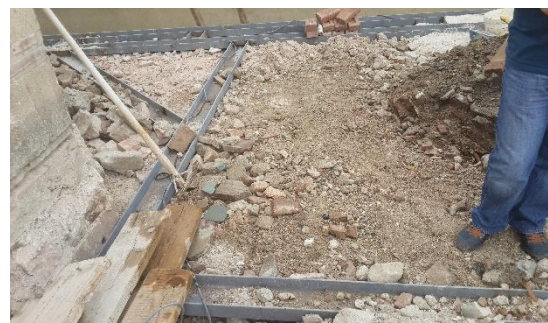
Figure 2.19. Application of double steel girder (2U160) on the load bearing walls

Furthermore, steel girder elements were anchored at the top level of the load bearing walls aiming at structural integrity of the mosque (Figure 2.19). On the North Wall, single U160 steel girders were anchored whereas double U160 steel elements were implemented to the rest of the load bearing walls (See Figure 2.15). All steel elements were fixed to the walls by using steel anchors after hydraulic lime-based injection was applied to the anchor holes. The connection between elements on the main prayer hall walls and portico walls was provided by single U160 steel elements (Figure 2.19(d)). Additionally, parallel

double steel profiles were connected to each other by using U160 in every 1 meter (Figure 2.19(a) and Figure 2.19(b)). Finally, steel girders were covered with horasan mortar and the dome, top surface of the walls and portico was coated with lead cover as shown in Figure 2.20.

(a) West Wall

(b) Portico Wall

(c) Connection of the members

(d) Connection between members

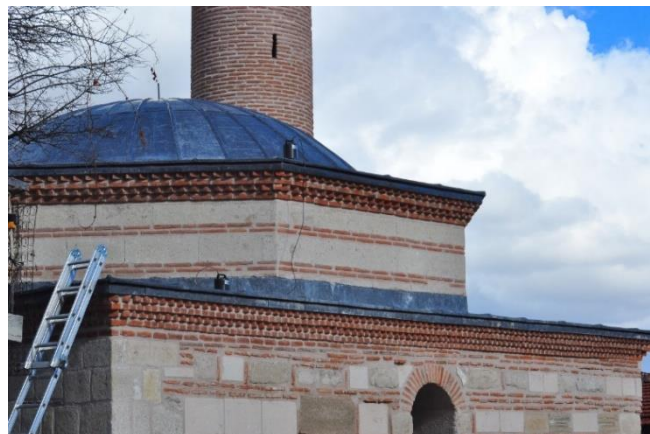
Figure 2.20. Lead covering after steel girder retrofitting

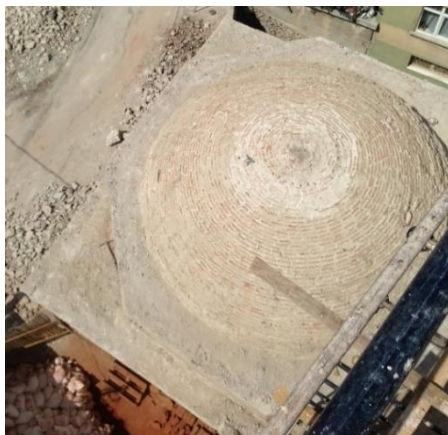
Figure 3.3. *Configuration of the structural components*

(a) *In-situ*

Within the scope of the study, the vast majority of the structural volume was modelled. Since no damage was reported on the minaret, it was not included in the numerical model. To represent retrofitted Kütahya Kurşunlu Mosque, structural scheme was constructed by using beam, shell and solid elements. A set of beam elements were used to represent the steel girder elements on the retrofitted mosque. Shell elements constituted the load bearing walls, arcades, piers, dome and drum. In addition, the simplified geometry considers the pendentives above the portico as slab which was also modelled by shell elements. The shell elements represent the middle plane of the structural elements. Therefore, a necessity for different arrangements from the reality was arisen. For instance, the connection between the dome, octagonal drum and load bearing walls were provided by pendentives which results different arrangement of middle planes of the components in reality (Figure 3.3). However, the numerical model assumes that the octagonal drum and walls were located in the same middle plane (Figure 3.3(b)). A set of solid elements were used to model pendentives instead of shell elements. The pendentives have volume which is difficult to be simplified and be representative in terms of stiffness by using shell elements (Figure 3.4). Moreover, the location of the steel girder elements differ from the reality due to the limitations of the shell elements adopted for the walls in the numerical model (See Figure 2.15 and Figure 3.5).

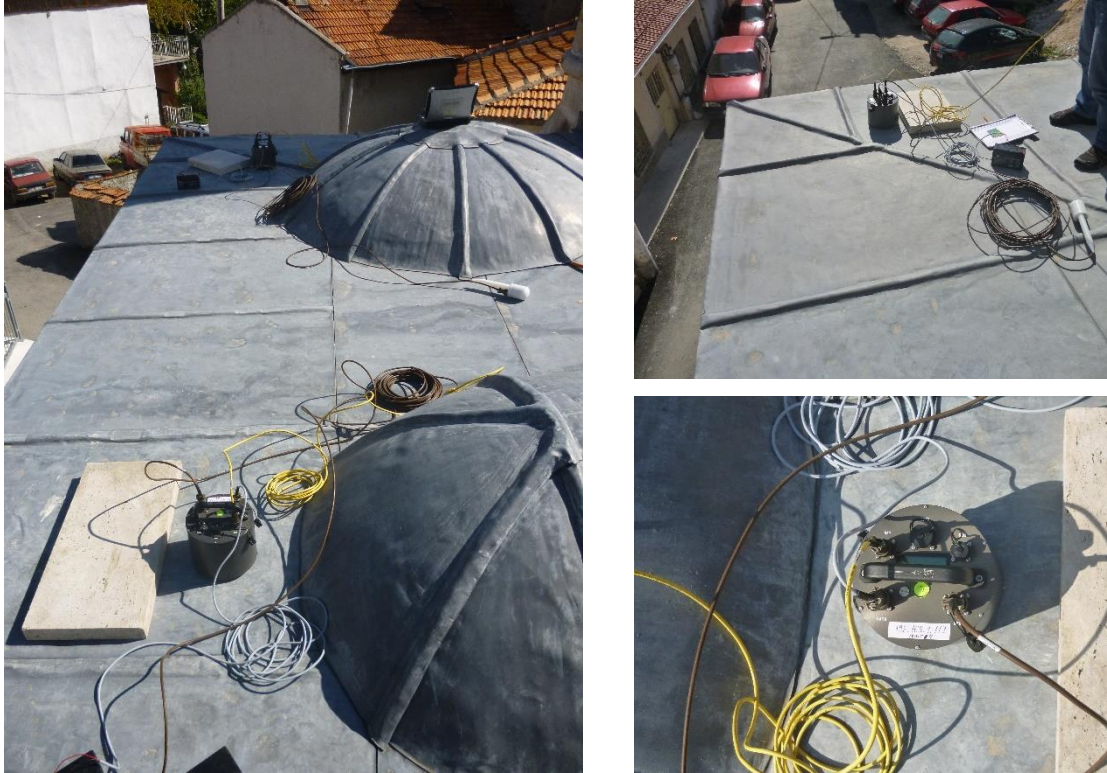
Figure 4.3. Test equipment; Left: Base station and 1st station, Right top: 4th station, Right bottom: accelerometer at the base station

accelerometer was placed to 7 different locations on the mosque. In total, there are 8 stations, including reference station. Reference station was operated during the measurement while approximately 20 minutes spend at each station. The test was performed considering seven measurement setups. Location of each station on the Mosque and test equipment during the real application are shown in Figure 4.2 and Figure 4.3, respectively. Locations of the stations was decided regarding to the modal response of the preliminary numerical model. The selected points seem to be the most convenient locations based on identifying in-plane and out-of-plane movement of the components.

In order to perform ambient vibration tests, two digital triaxial accelerometers, namely Güralp 5TCDE, were used. The accelerometers have a frequency range of DC-100 Hz with sensitivity range from ± 0.1 to $\pm 4.0g$ and 10 V/g of resolution. Additionally, a data acquisition system with 24 bits resolution was used together.

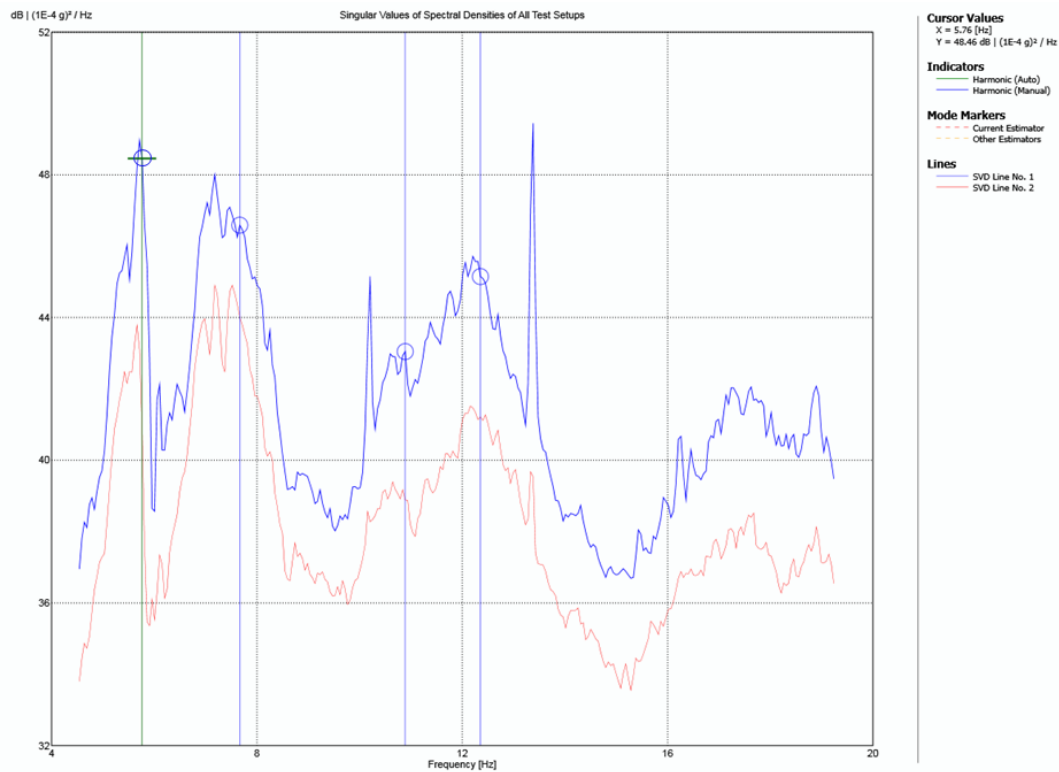
Figure 4.4. Singular values of spectral densities of all setups, EFDD method

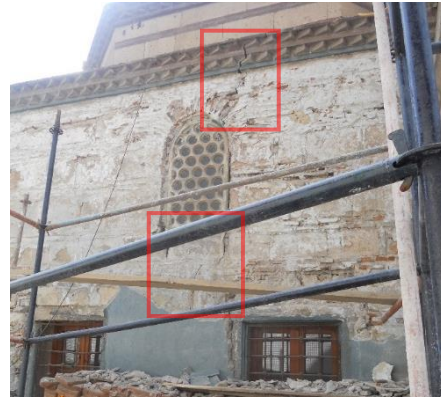
(b) Cracks on the east façade

Figure 5.5. The non-retrofitted numerical and real damage on the east façade, maximum principal strain distribution at load factor 0.27g in +X direction

(Figure 5.5). At last, the dome experiences damage which seems to be originated because of the in-plane mechanism of the transversal walls and out-of-plane movement of longitudinal walls in +X direction (Figure 5.6).

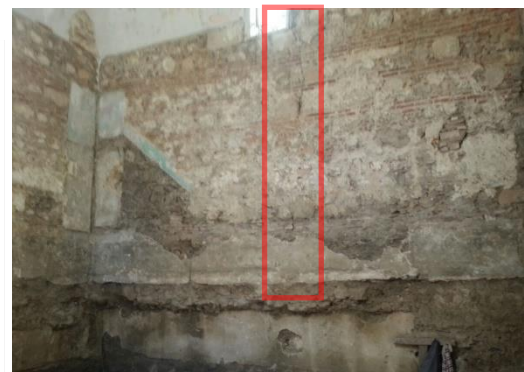
Figure 5.9. Comparison of the non-retrofitted numerical and real damage on the West Wall, maximum principal strain distribution at load factor $0.3g$

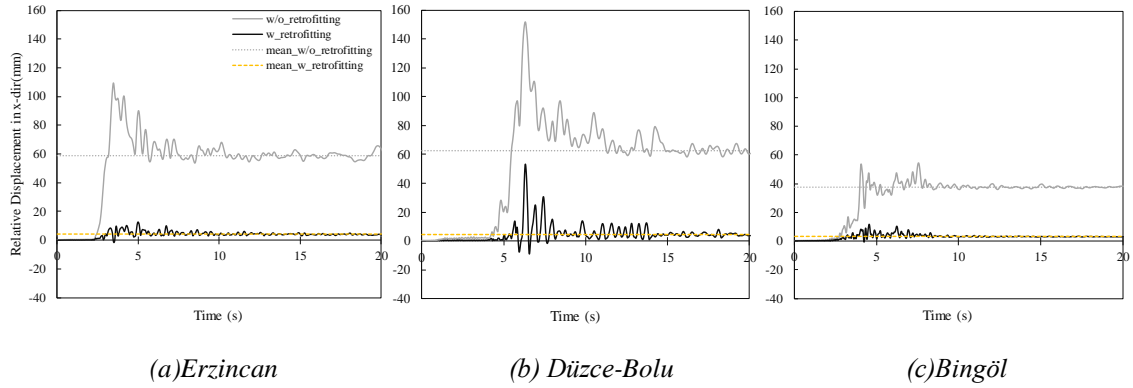
Figure 6.18. Change in out-of-plane displacement relative to the west wall

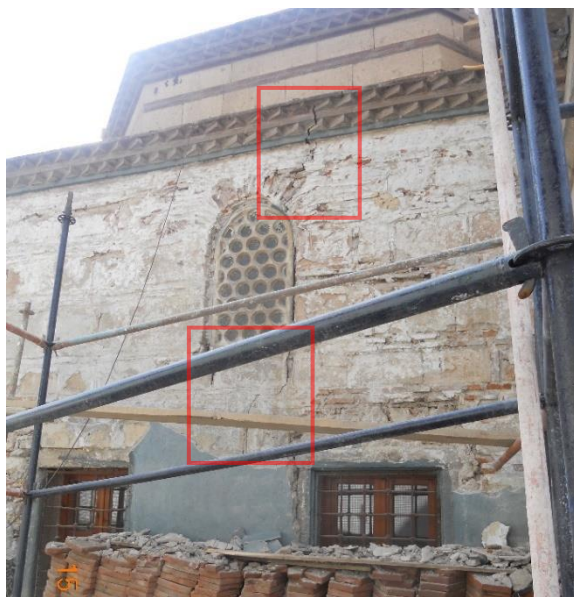
(a) Vertical crack on the East façade

(b) Total tensile principal strains on the East façade, under the Bingöl EQ ($t=3.99s$)

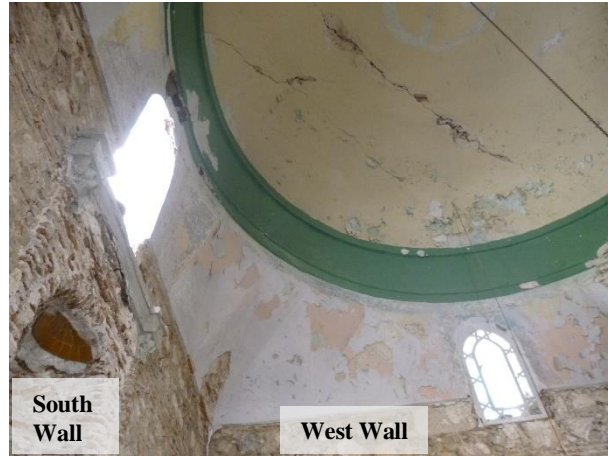
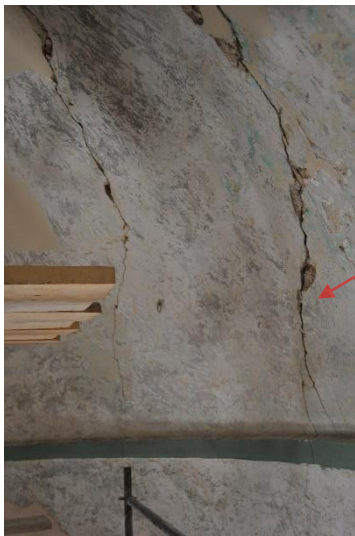
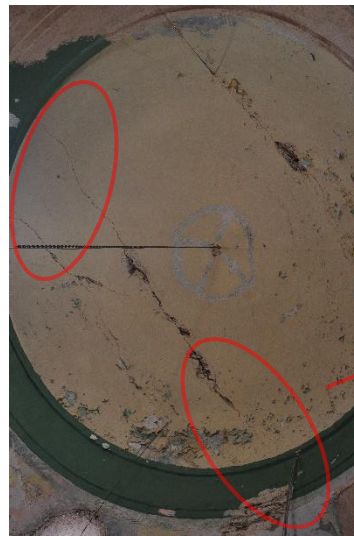
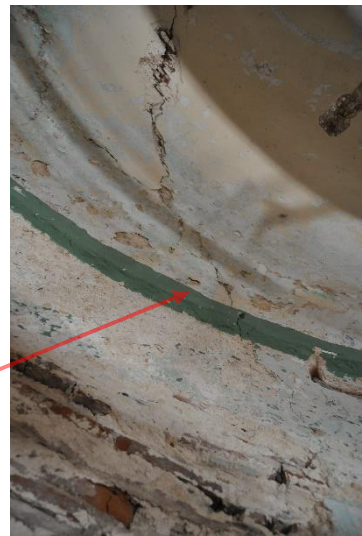
(a) Interior face of the south and west wall and intrados

(b) Dome-drum-south wall

(c) Intrados

(d) Dome-drum-west wall

Additionally, several cracks were reported on the East façade (Figure 6.34). Even though the image of the real mosque is very limited, several conclusions related with the finite element model damage correlation can be done. Vertical damage is located on upper and lower parts of the window opening which is similar with the dynamic analysis resulted by Bingöl loading. Moreover, internal damage is observed on the dome as given in Figure 6.35. Figure 6.35(a) is given in order to show the orientation and location of the

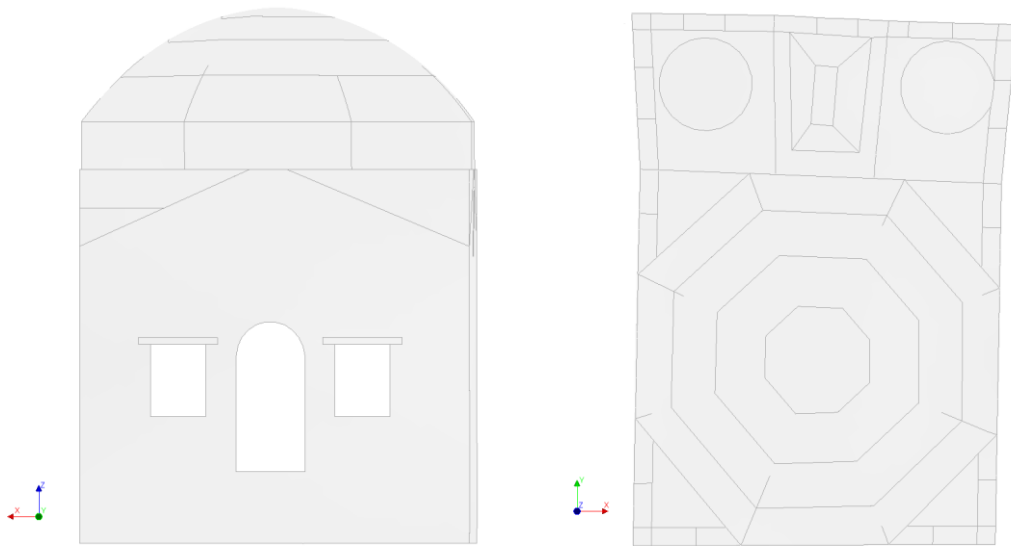
(c) View point C; North Wall
